DEPARTMENT OF TRANSPORTATION

Contract #: 04-0120F4Cty: SF/ALA Rte: 80 PM: 13.2/13.9File #: 69.28**WELDING INSPECTION REPORT****Resident Engineer:**Pursell, Gary**Address:** 333 Burma Road**City:** Oakland, CA 94607**Report No:** WIR-014885**Date Inspected:** 10-May-2010**Project Name:** SAS Superstructure**OSM Arrival Time:** 645**Prime Contractor:** American Bridge/Fluor Enterprises, a JV**OSM Departure Time:** 1845**Contractor:** Zhenhua Port Machinery Company, Ltd (ZPMC), Changxing Island **Location:** Shanghai, China**CWI Name:** Geng Wei, Zhu Zhong Hai.**CWI Present:** Yes No**Inspected CWI report:** Yes No N/A**Rod Oven in Use:** Yes No N/A**Electrode to specification:** Yes No N/A**Weld Procedures Followed:** Yes No N/A**Qualified Welders:** Yes No N/A**Verified Joint Fit-up:** Yes No N/A**Approved Drawings:** Yes No N/A**Approved WPS:** Yes No N/A**Delayed / Cancelled:** Yes No N/A**Bridge No:** 34-0006**Component:** Orthotropic Box Girder(OBG)**Summary of Items Observed:**

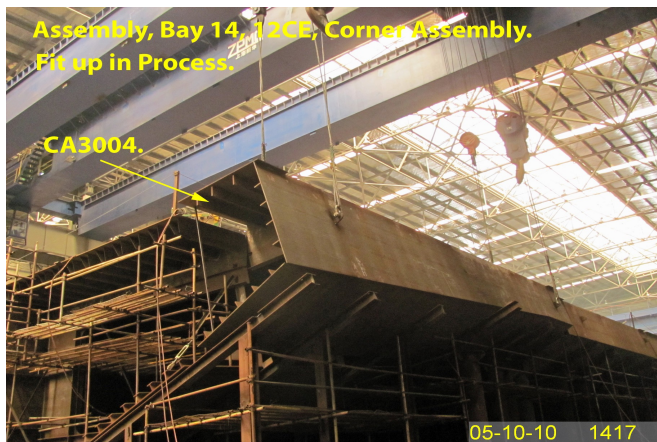
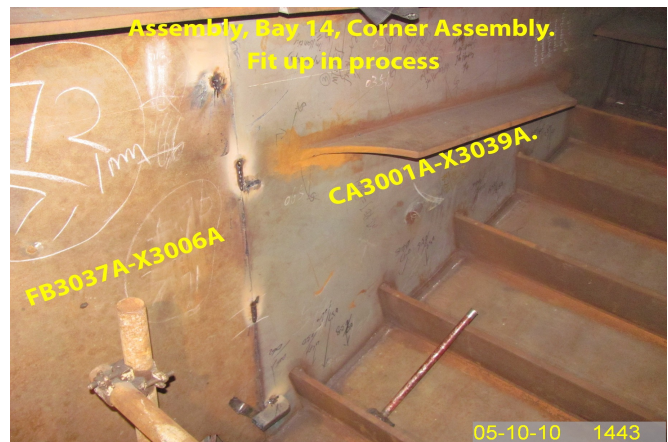
During Random Visual in process Inspection, this QA inspector observed fit-up of Corner Assembly CA3004 to Segment 12CE. The attached photographs provide additional detail.

During Random Visual in process Inspection, this QA inspector observed fit-up of Corner Assembly CA3001A (X3039A) to Floor Beam FB3037A (X3006A). The attached photographs provide additional detail.
